Workers were filling one of two MIBC tanks with water from fire hydrant to valve.

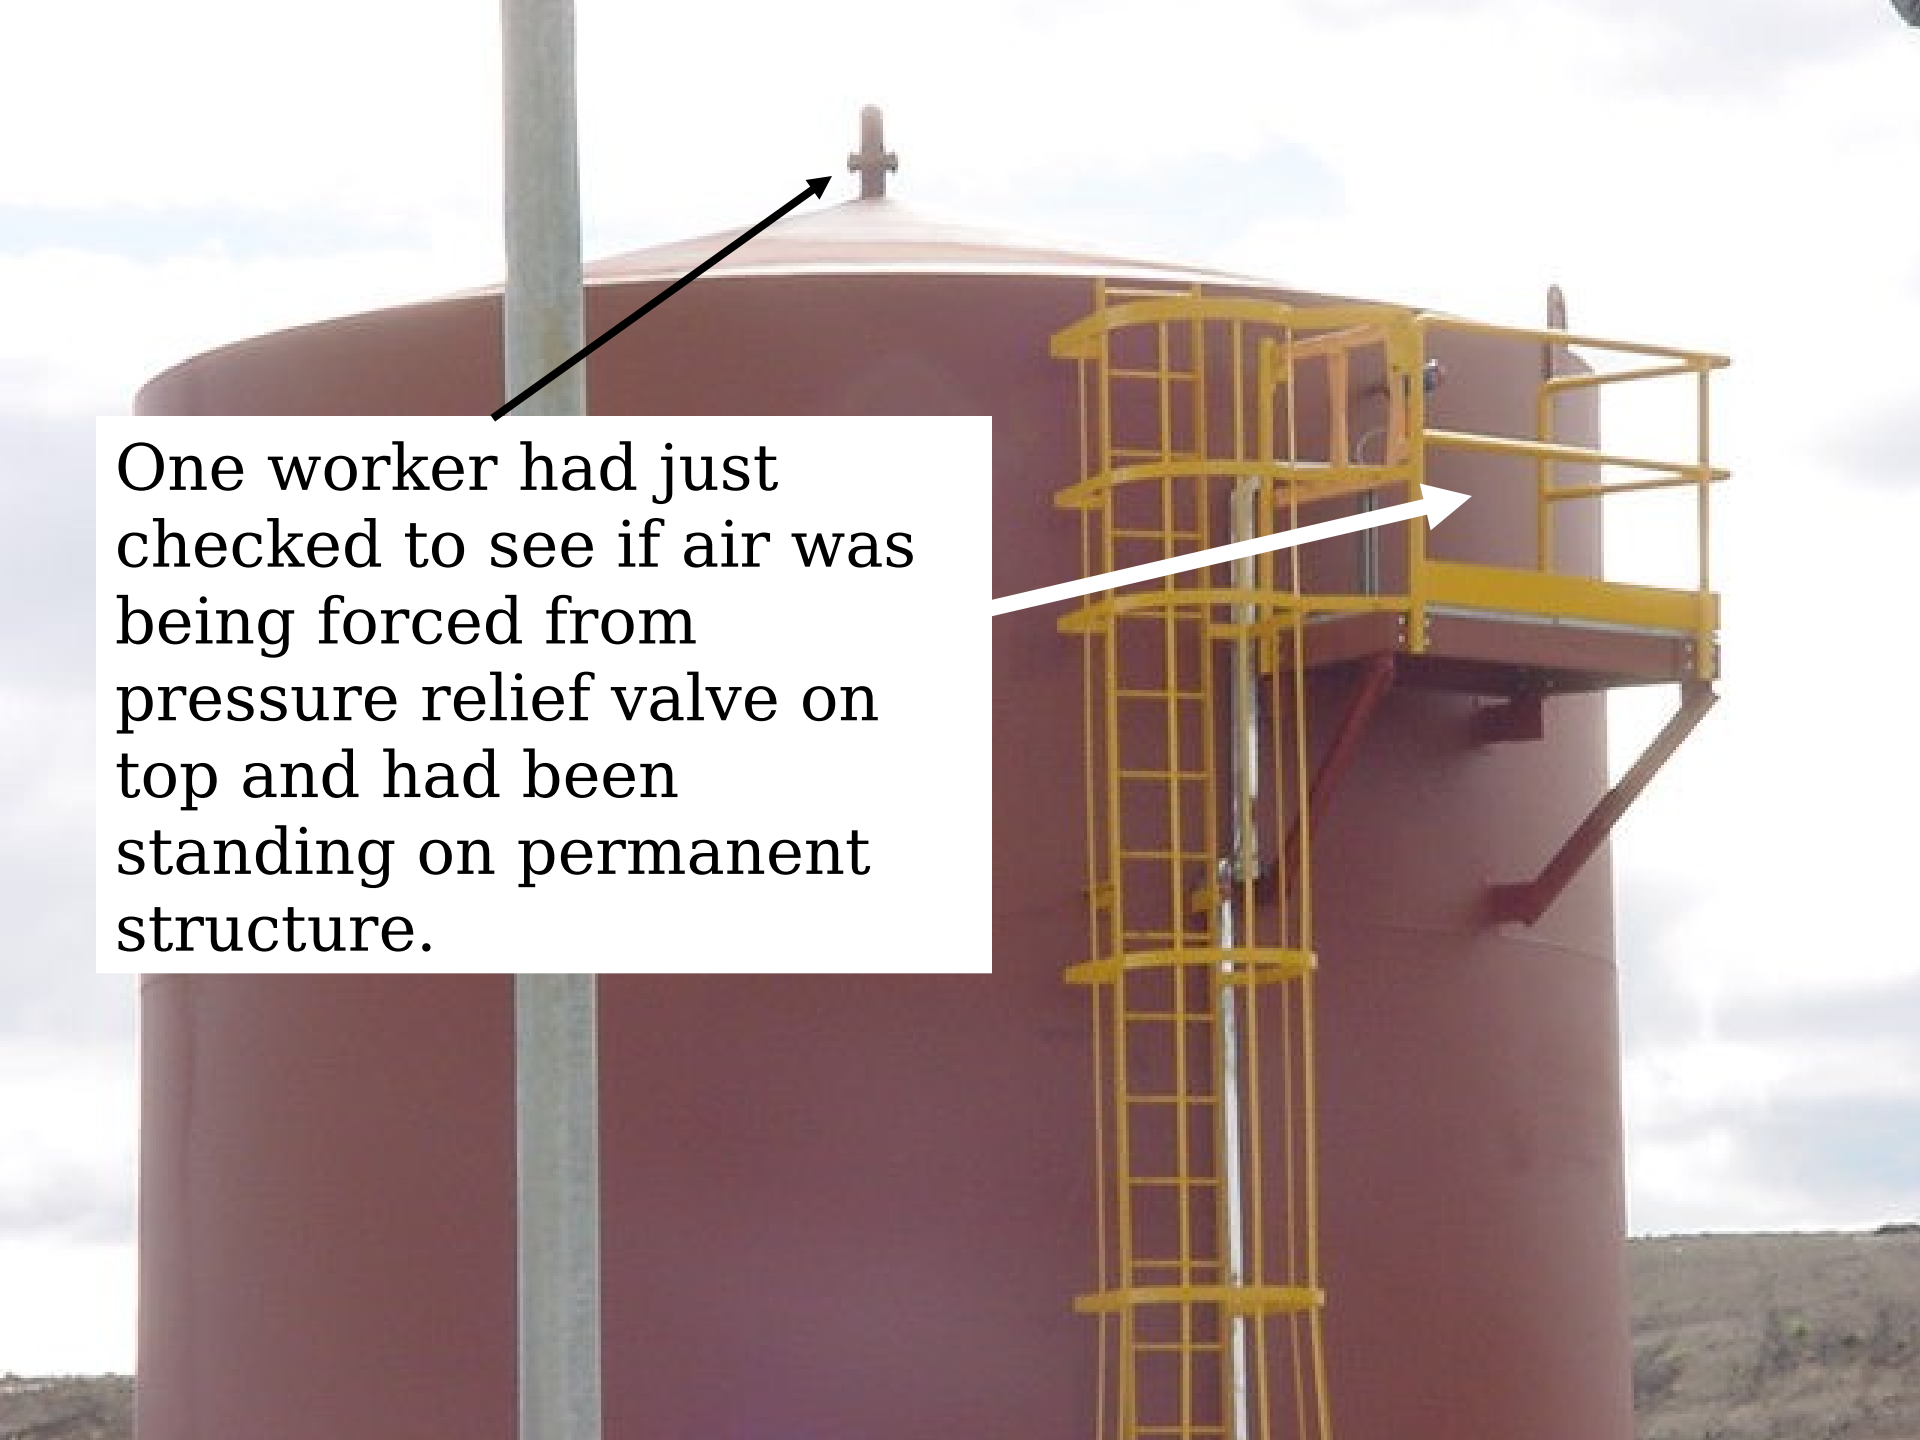
One worker had just checked to see if air was being forced from pressure relief valve on top and had been standing on permanent structure.

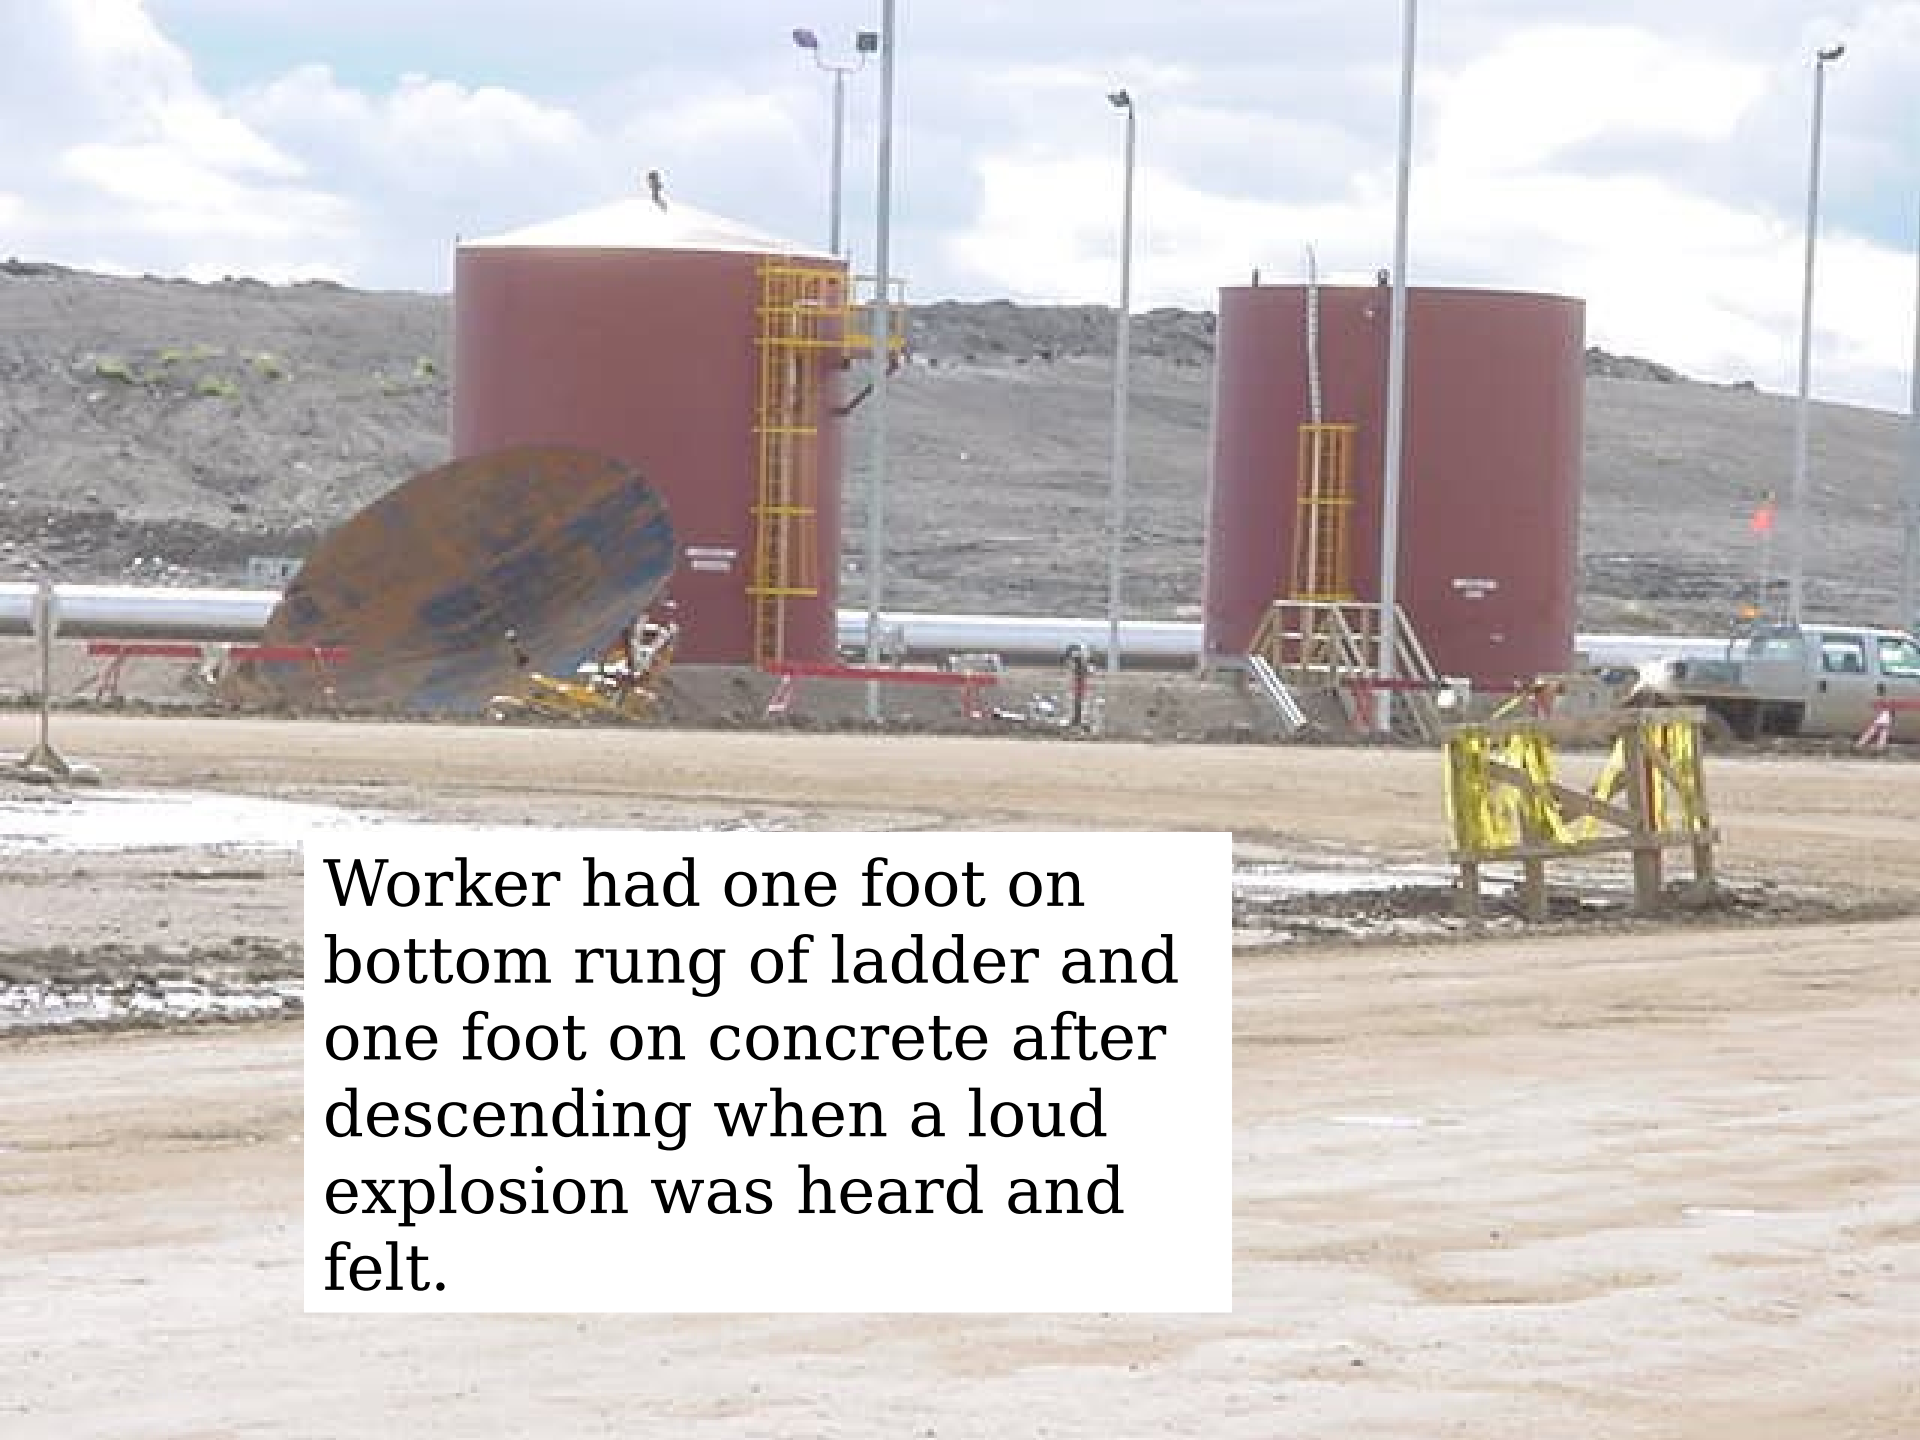
A photograph of an industrial site, likely a refinery or chemical plant. In the background, there are two large, cylindrical red storage tanks. A worker is visible on a yellow ladder attached to the left tank. To the left of the tanks, there is a large, rusted, dome-shaped object. In the foreground, there is a dirt area with some yellow caution tape or barriers. A white pickup truck is parked on the right side. The sky is cloudy.

Worker had one foot on
bottom rung of ladder and
one foot on concrete after
descending when a loud
explosion was heard and
felt.

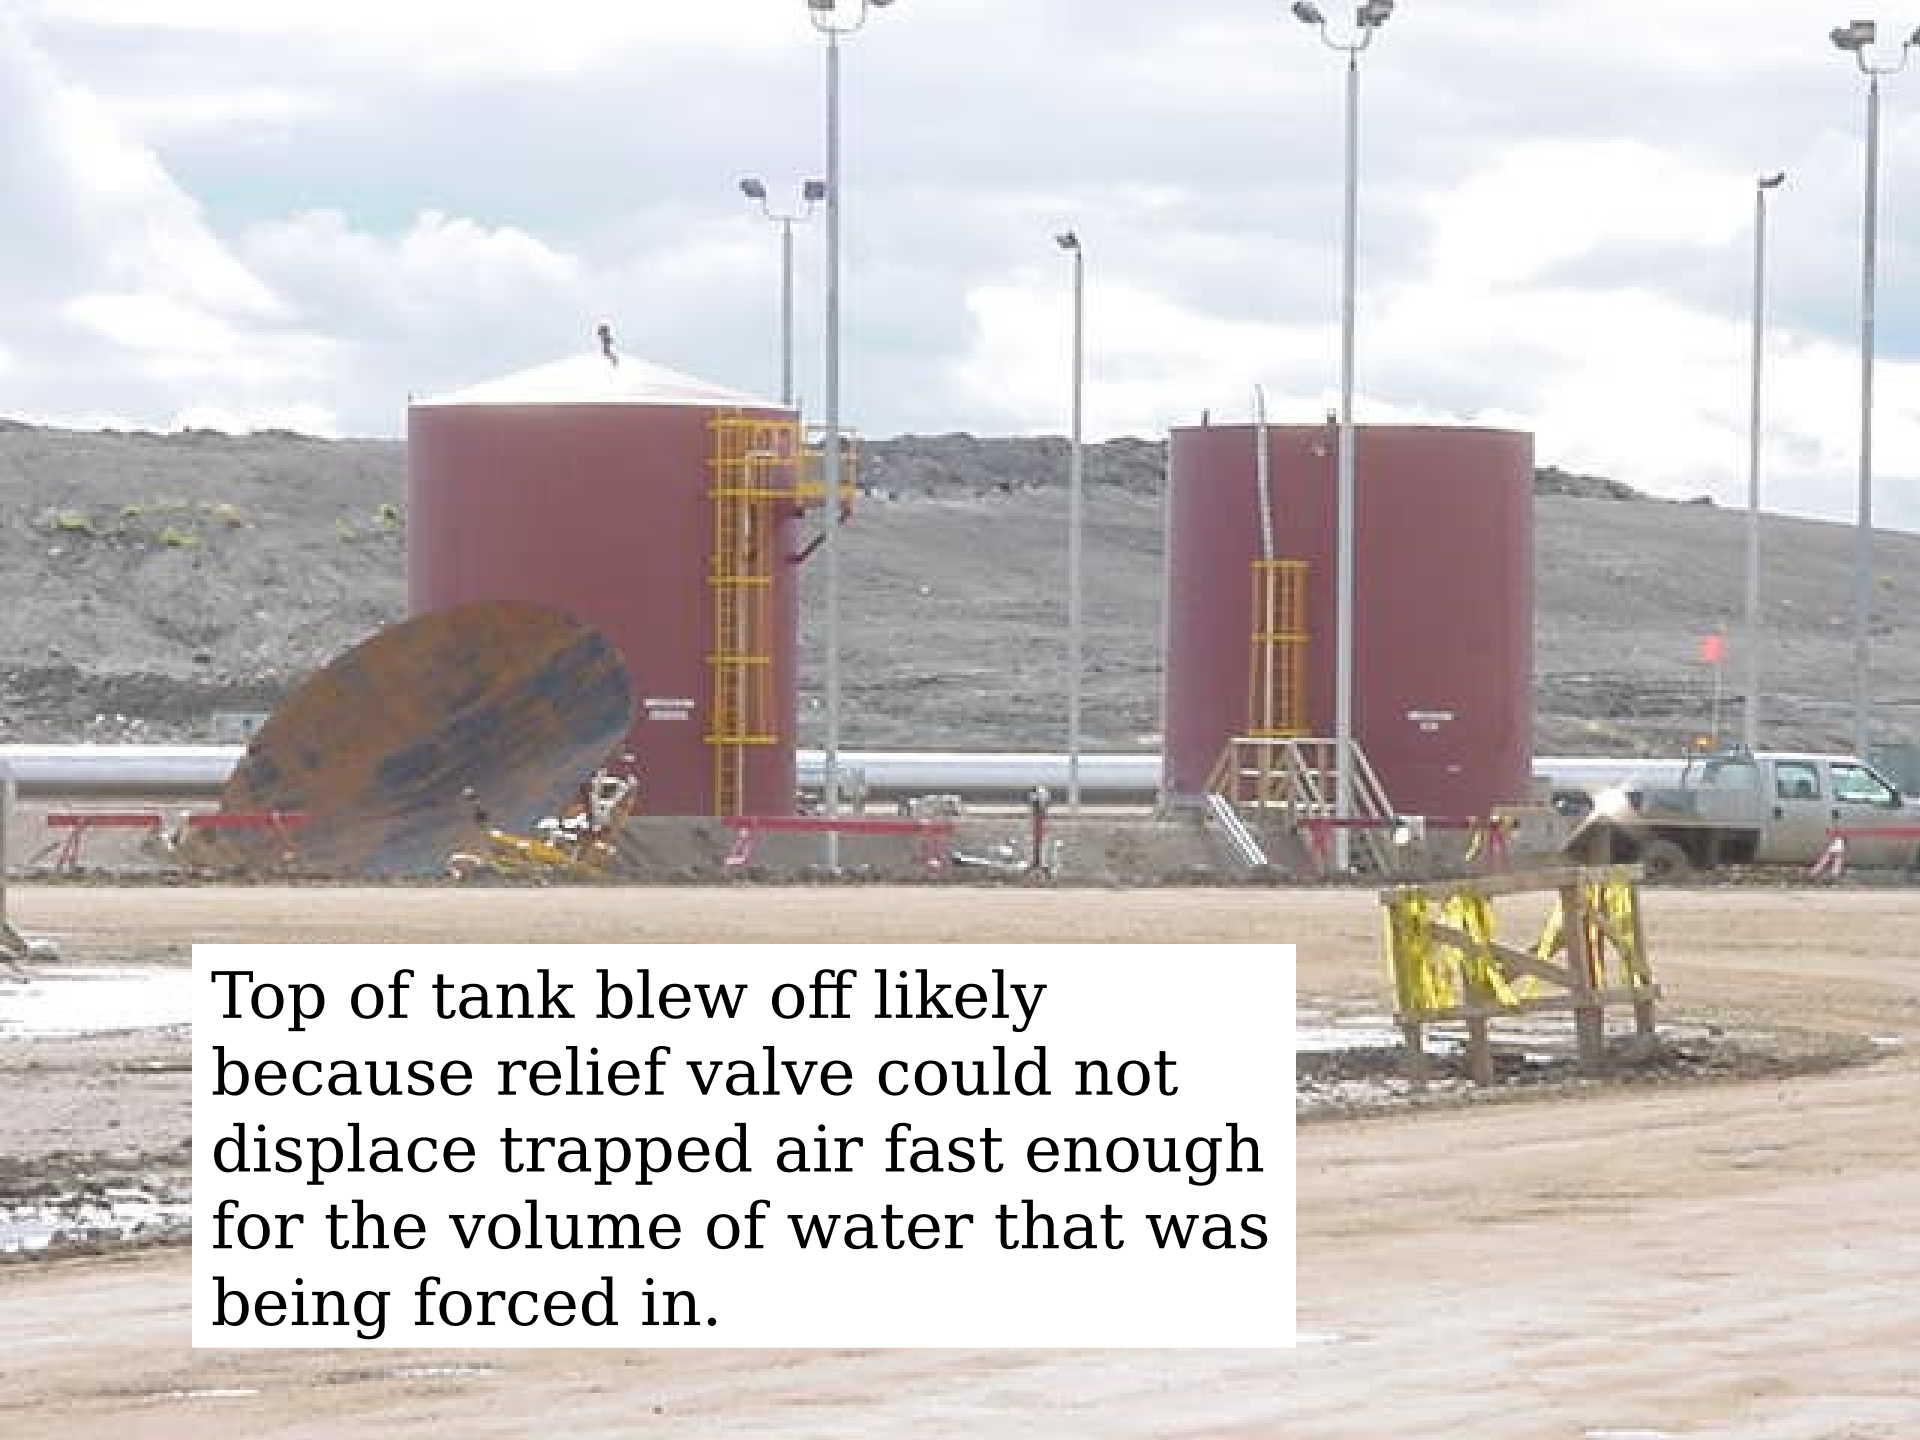
Top of tank blew off likely because relief valve could not displace trapped air fast enough for the volume of water that was being forced in.
